MERLIN LEGEND® Communications System

Release 6.0 Maintenance and Troubleshooting

> 555-660-140 Comcode 108137431 Issue 1 February 1998

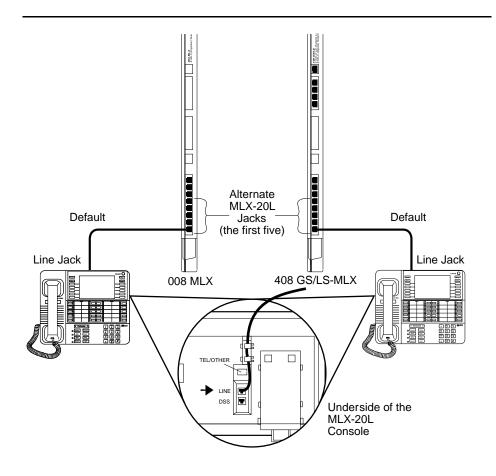
Figure 1-1. Setting Up the MLX-20L Console

To connect an MLX-20L console to the control unit, follow the steps below. Refer to Figure 1–1 on page 1–5.

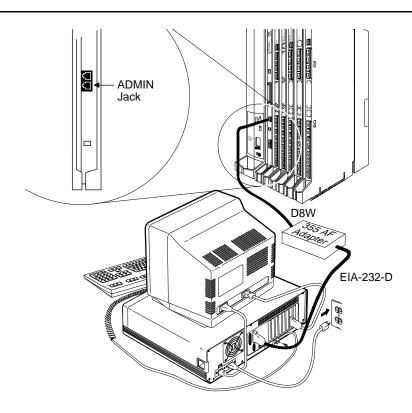
Figure 1-2. Setting Up the PC

Plug a PC into the ADMIN jack on the processor module as shown in If you are using a remote PC for system programming, see "Remote Programming Maintenance" on page 1–6.

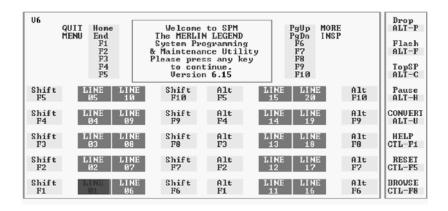
Figure 1-4. The SPM Display

SPM screens simulate the MLX-20L console (Figure 1-4).

Each SPM screen includes a 7-line by 24-character console simulation window that corresponds to the display area of the MLX-20L telephone. To the right and left of this console simulation window are columns, listing the keys that correspond to similarly located buttons on the MLX-20L telephone.

The 10 function keys, identified on screen as [f] through [f10], are used to select screen options. When a screen displays several choices, press the function key identified by the label next to your choice. (If you were working on the console you would press the telephone button next to your choice.)

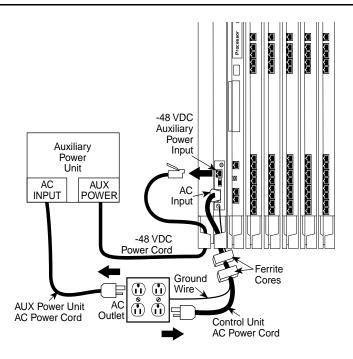
Figure 1-6. Disconnecting AC Power

To disconnect the AC power, see Figure 1–6 and follow the steps below.

- 1. Disconnect the AC power to each auxiliary power unit by unplugging the power cord from the wall outlet.
- 2. Disconnect the AC power to each carrier by unplugging the power cord from the wall outlet.

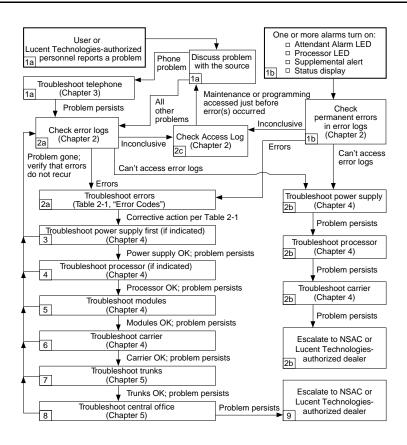
Figure 1-7. Maintenance Strategy

The maintenance strategy presented in this section is only a guideline, not a fixed procedure. Refer to Figure 1–7 on page 1–22 whenever you are uncertain about how to proceed. It provides guidelines for analyzing problems in non-networked systems.

If a system alarm turns on (see the top-right area of Figure 1–7 on page 1–22), begin troubleshooting by checking the permanent errors in the error logs.

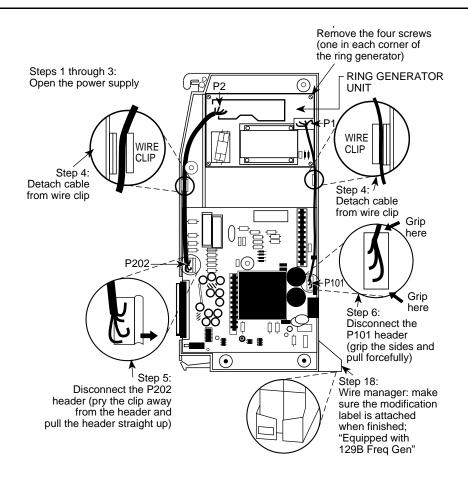
Figure 4-2. Replacing a Ring Generator

Take time to ensure that the on/off faceplate on the front of the power supply housing is aligned and inside the top cover.

▶ 17. Carefully, taking time to make sure the on/off faceplate stays aligned, turn the module over and replace the five screws.

- ▶ 18. Verify that the modification label (Equipped with 129B Freq Gen) is attached to the front of the power supply (shown in Figure 4–2).
 If not, attach the label supplied with the new ring generator.
- ▶ 19. Reinstall the power supply; follow Steps 5–8 in <u>"Replacing the Power Supply" on page 4-10.</u>

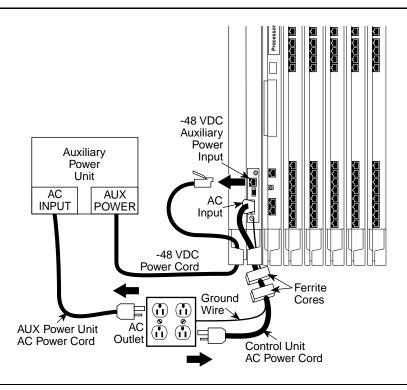
Figure 4-3. Replacing an Auxiliary Power Supply

To replace the auxiliary power unit, follow the steps below. Refer to Figure 4–3 throughout this procedure.

- ▶ 1. Make sure the switch on the power supply module is turned off.
- Unplug the power supply and the auxiliary power unit from the AC outlet.
- 3. Disconnect the cord from the AUX POWER INPUT jack on the power supply module.
- ▶ 4. Remove the auxiliary power unit (with the two cords still attached).
- ▶ 5. Mount the replacement auxiliary power unit in place of the old one.
- ▶ 6. Plug the power unit line cord into the J2 DC OUTPUT jack on the replacement auxiliary power unit.
- 7. Plug the other end of the power unit line cord into the AUX POWER INPUT jack on the power supply.

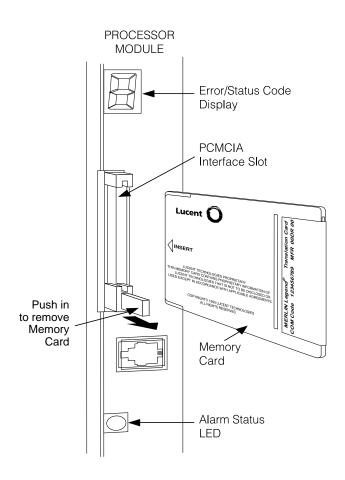
Figure 4-4. Inserting a Memory Card

▶ 2. Insert a Forced Installation or Upgrade memory card into the PCMCIA interface slot on the processor module.

See Figure 4-4.

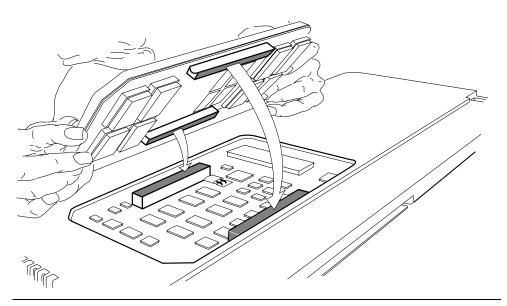
Figure 4-5. Replacing the Feature Module

- ▶ 6. Align the connectors on the new feature module with the connectors in the processor (see Figure 4–5).
- ▶ 7. Firmly press the new feature module into the processor.
- 8. Insert the processor back into the carrier. (For more information about inserting the processor, see Chapter 2 of *Installation*.)

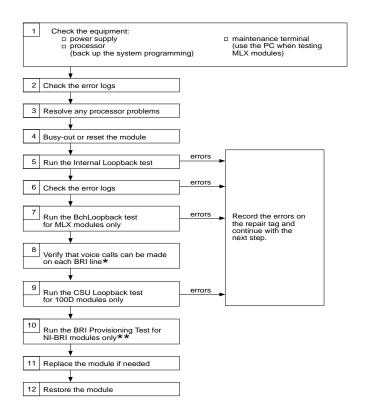
Figure 4-6. Module Test Process

<u>Figure 4–6</u> shows the module test process. Refer to it and the text that follows for the recommended approach to testing modules.

^{*} If any problem arises with the voice call on an NI-BRI module, run the NI-BRI Provisioning Test next. While the BRI test is running, you can run the voice test on the next module.

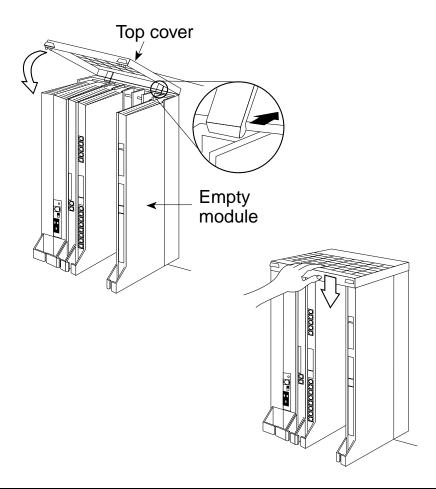
Figure 5-1. Installing the Control Unit Top Cover (Release 2.1 and Later)

To install the top cover, see Figure 5–1 and follow these steps.

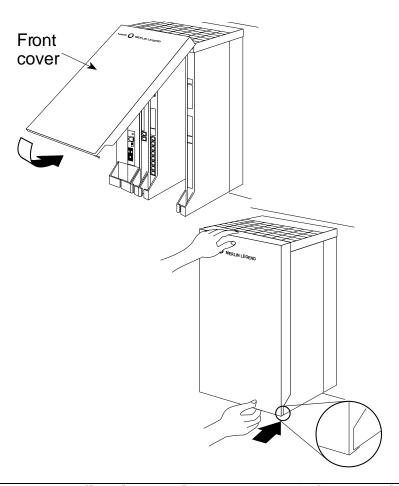
Figure 5-2. Installing the Control Unit Front Cover (Release 2.1 and Later)

To install the front cover, see Figure 5-73 and follow these steps.

- ▶ 1. Hook the top of the front cover onto the top cover.
- ▶ 2. Push down on the bottom of the front cover until it locks securely on the base of the wire manager on the modules.

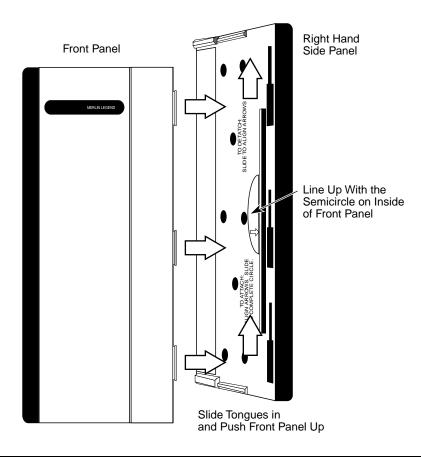
Figure 5-3. Assembling the Control Unit Housing (Release 2.0 and Earlier)

- ▶ 1. Assemble the control unit housing. See Figure 5–3.
 - If the housing is already assembled, go to Step 2.
 - If the housing is not assembled:
 - a Lay the front panel(s) face down.
 - b If you are housing more than one carrier, connect the front panels together by lining up the arrows and then sliding the panels until the semicircles form a complete circle.
 - c Connect the side panels to the front panel(s) similarly.

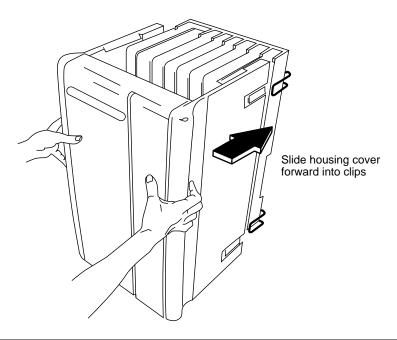
Figure 5-4. Installing the Control Unit Housing (Release 2.0 and Earlier)

- ▶ 2. Line up the wire clips attached to the carrier with the recesses on the outside of the side panels. See Figure 5–4.
 - If the wire clips are not attached to the control unit, see "Installing the Housing Clips" in Chapter 2 of *Installation*.
- ▶ 3. Push the panels back until the clips hook over the tabs and rest in the recesses.

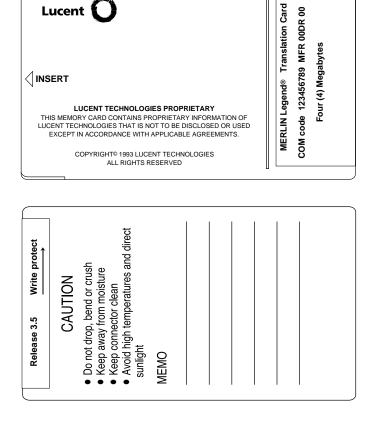
Figure D-1. PCMCIA Translation Memory Card

Figure D–1 shows a sample Translation card.

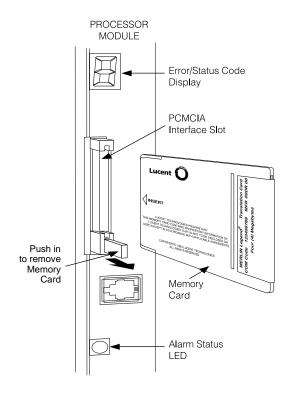
Figure D-2. Inserting the Memory Card

To insert the card, hold the card with the Lucent Technologies logo facing up and the arrow pointing toward the slot. See <u>Figure D–2</u> for the proper way to insert the memory card into the slot on the processor module.
